**Technical Evaluation Memorandum  
for the Radiation Technology  
Superfund Site, Operable Unit 3  
Contract No. W912DQ-11-D3006**

**Site Number NJD047684451**

**December 2012**

**Photographs of Site  
Buildings/Structures from October  
2012 Site Walk**

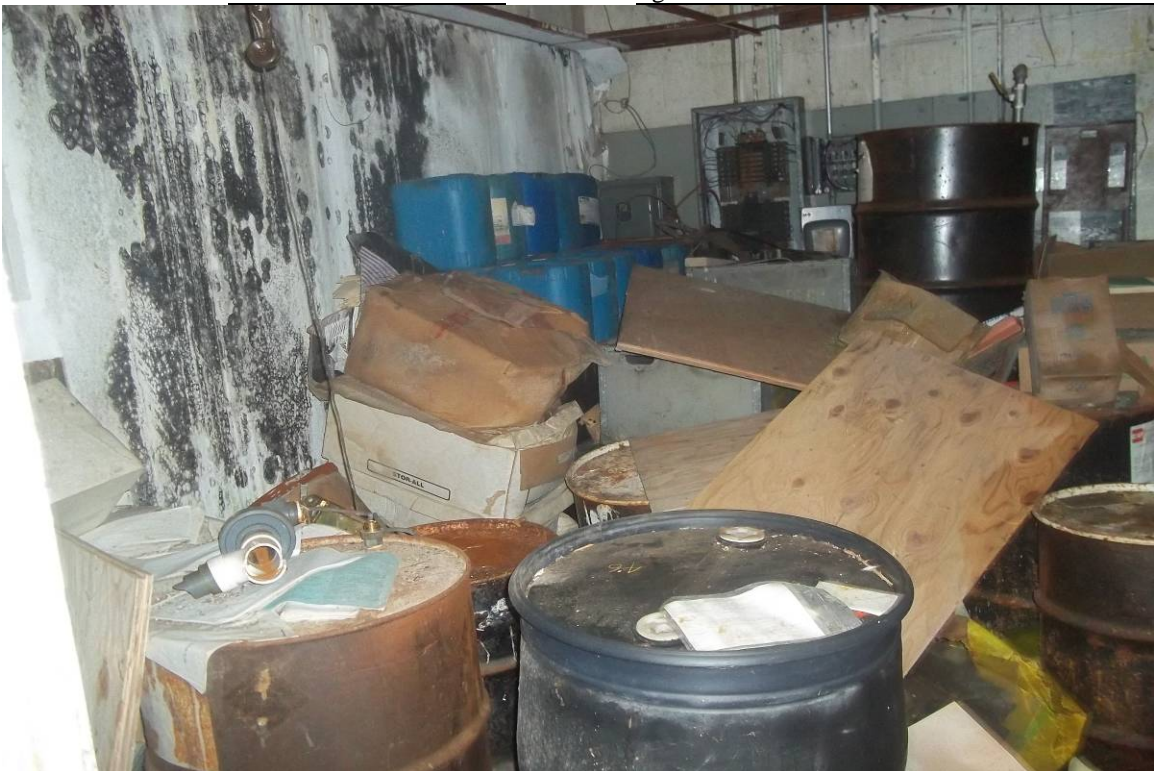
**Subject:** Southwest room in R-21 with multiple 55 gallon drums.

This building contains approximately 30 drums/containers (55-, 30-, and 5-gallon), and other debris. E & E recommends hazard categorization and proper disposal of the drums/containers. In addition, collection of one concrete chip sample from the drum room and one composite surface soil sample from around the building for general characterization and disposal purposes, and for use in the FFS.

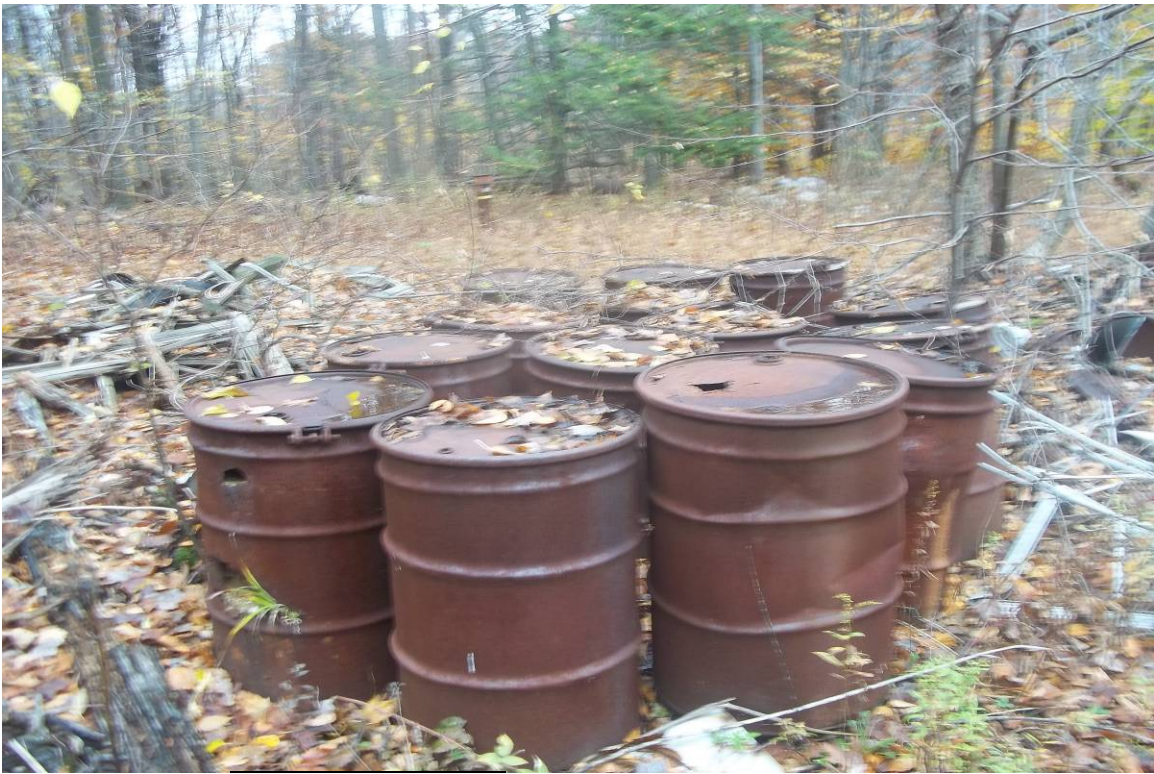
**Subject:** Drums located in waste disposal area (north end).

Waste Disposal Area	The Waste Disposal Area is located approximately 150 feet east of R-47. The area is situated in the woods and contains miscellaneous debris including an empty rusted 55 gallon drum, metal debris, and metal piping.	Waste disposal.

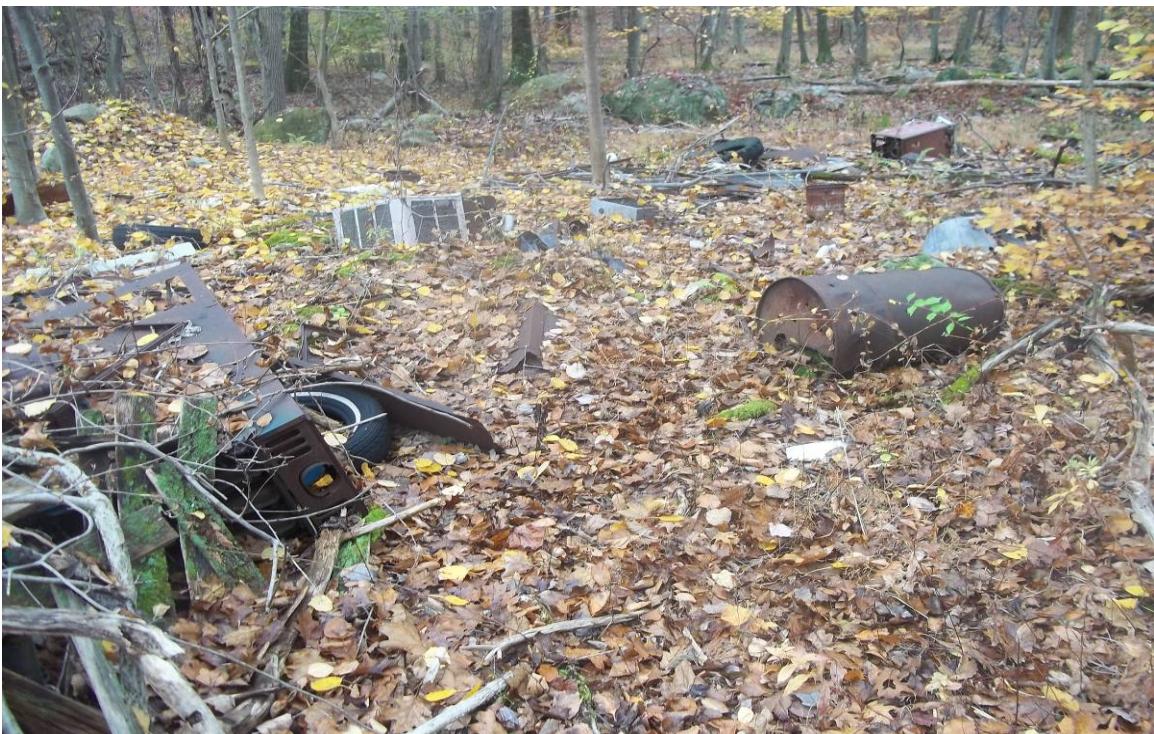
**Subject:** South end of waste disposal area.
